XtremeAir GmbH, Harzstr.2, D-39444 Hecklingen Tel: +49 39267 60999 0, Fax: +49 39267 60999 20 www.xtremeair.de info@xtremeair.de	Document No. SB-2013-005
		Issue: A.02
DOA-Nr.: EASA.21J.360	Service Bulletin SB-2013-005	Date: 28.06.2013

Subject: Throttle Control

Aircraft type affected: XA41 & XA42

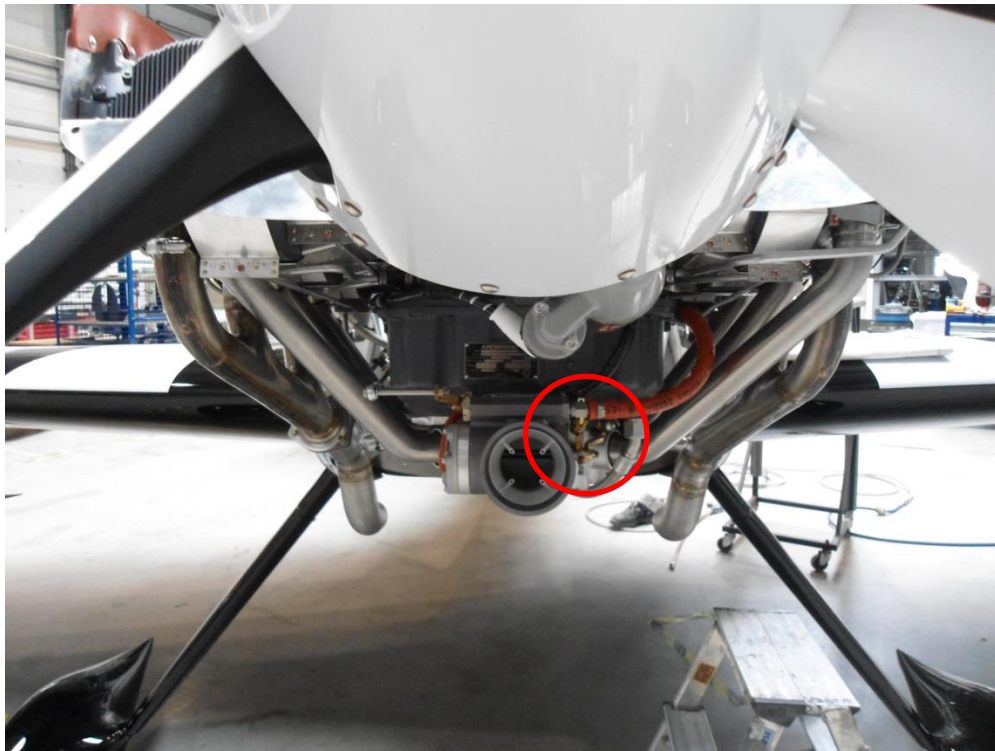
Figure 1: Location of the throttle control link.

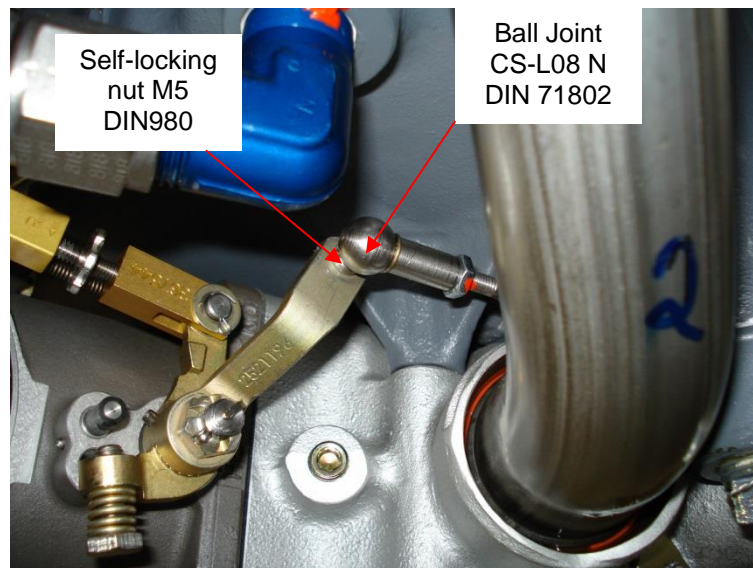
Background: The throttle control ball joint has been replaced by a rod end bearing to avoid a disconnection of the throttle control link in case of a ball bearing failure.

Figure 2: Detail of the throttle control link before the change.

1. Remove the cowling
2. Remove the self-locking M5 nut (See Figure 2).
3. Unscrew the Ball Joint.
4. Screw the Heim HF-3M rod end in its place.
5. Reassemble the throttle link as shown in Figure 3. Make sure to replace the split pin.
6. Reassemble the cowling.
7. Check the throttle control from stop to stop.

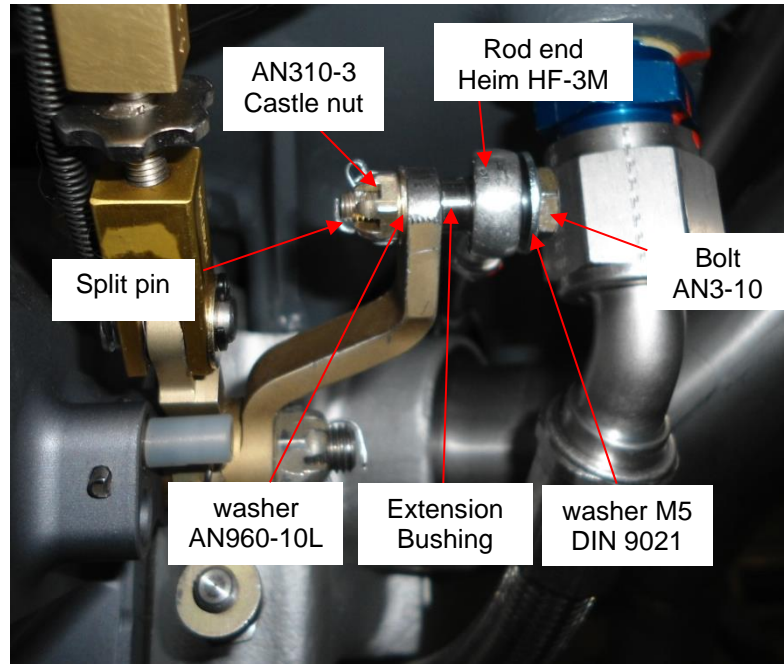
Figure 3: Detail of the throttle control link after the change.
