XtremeAir GmbH, Harzstr.2, D-39444 Hecklingen Tel: +49 39267 60999 0, Fax: +49 39267 60999 20 www.xtremeair.de info@xtremeair.de	SB-2013-008
		Ausgabe: A.04
DOA-Nr.: EASA.21J.360	Service Bulletin SB-2013-008	Date: 01.07.2014

MANDATORY

Subject: Engine Mount

Aircraft model affected: XA42, XA41

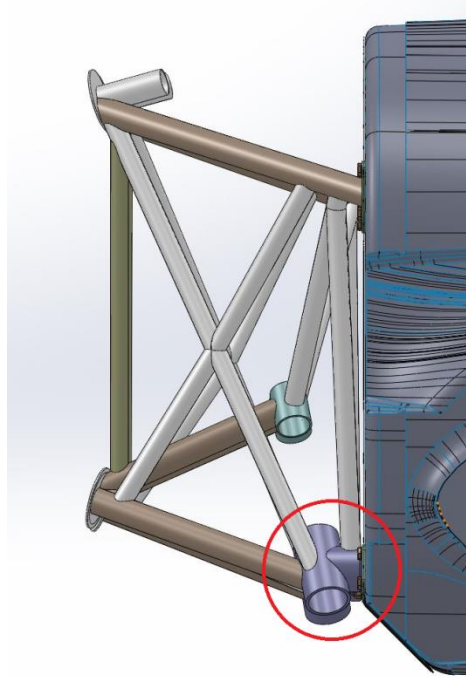
Background: A crack was reported by an operator in a weld seam between the lower left landing gear attachment bearing and the lower engine mount to firewall attachment-plate. Further investigation showed that all engine mounts from a specific supplier may be affected.

Note: Particularly the welds between the lower landing gear attachment bearing and the lower engine mount to firewall attachment-plate are susceptible to cracking in aircraft operated regularly from rough airfields. Figure 1 and 2.

Figure 1: Welding seams area where extra attention is needed during inspection

3. When in doubt, perform a dye penetrant inspection, refer to AC 43.13-1B.
4. If cracks are found, replace the engine mount before next flight.
5. Reinstall the engine cowling.
6. Repeat the above inspection after every 10 flights.

1. Replace the affected engine mount with Engine Mount P/N XA42-7120-151 provided by XtremeAir.

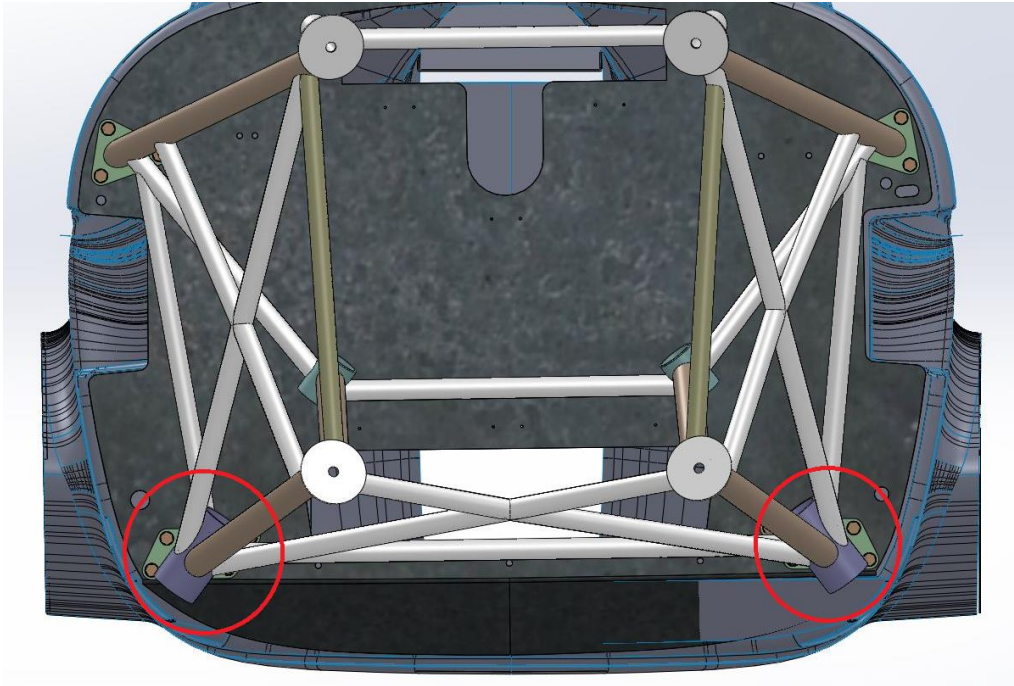
Figure 2: Welding seams area where extra attention is needed during inspection
