XtremeAir GmbH, Harzstr.2, D-39444 Hecklingen Tel: +49 39267 60999 0, Fax: +49 39267 60999 20 www.xtremeair.de info@xtremeair.de	Document No. SB-XA42-2018-017
		Issue: A.00
DOA-Nr.: EASA.21J.360	Service Bulletin	Date: 03.08.2018

Subject:	Front baffling improvement
Aircraft type affected:	XA42
Serial numbers affected:	MSN 132 and 137 – 151
Compliance:	At user discretion
Time of Compliance:	During the next scheduled maintenance
Purpose:	To notify the owner of the subject aircraft of an improvement of the LH front baffling.
Background:	A narrow gap between the LH front baffling and the lower cowling leads to rubbing and wearing of the baffle seal. Damage of the lower cowling could occur.
Manpower:	It is estimated that three (3) man-hours are necessary to apply this service bulletin.
Materials:	The following materials are necessary: (6) ea. Aluminum pop rivet DIN7337-A-4x8 – or equivalent – Consumables: - Silicone baffle seal 1/8" x 2"
Accomplishment Instructions:	Read all the instructions and make sure the complete procedure is understood before starting the assembly work on the aircraft. In case of doubt, contact the manufacturer. <ol style="list-style-type: none"> 1. Remove the low

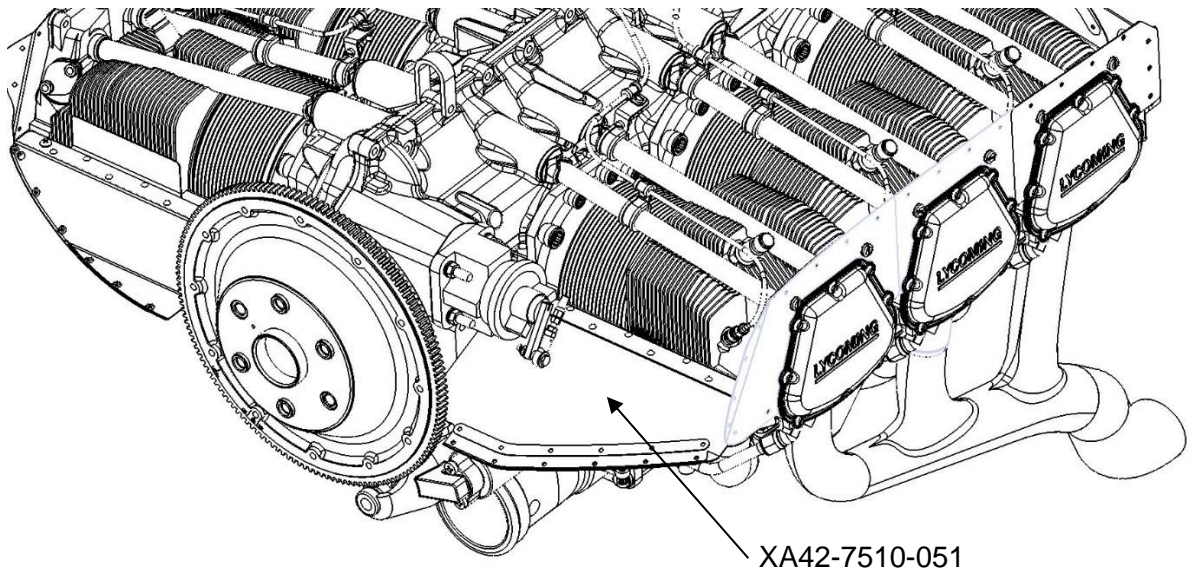
Figure 1: Identification of the LH front baffle XA42-7510-051

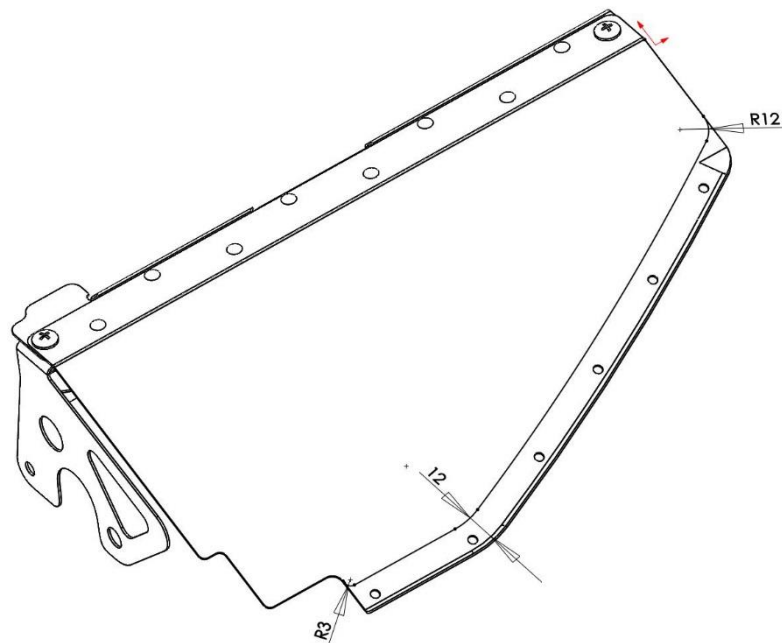
Figure 2: Marking of the trim contour

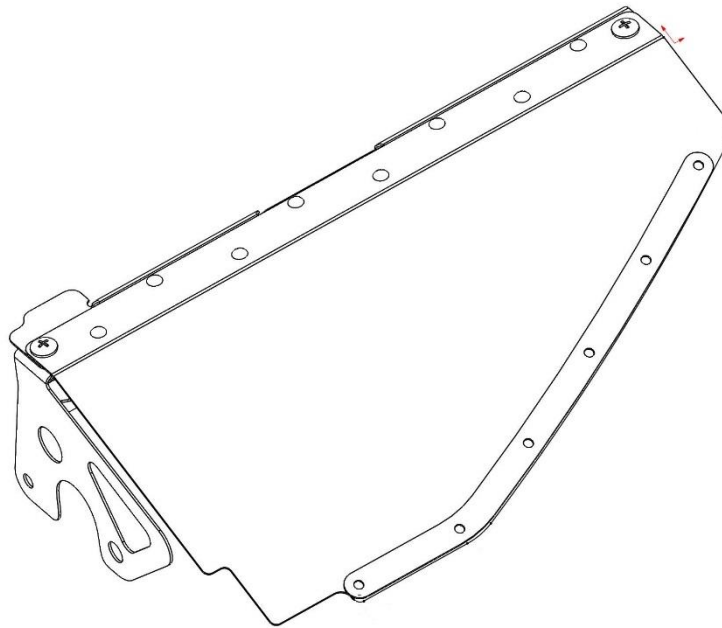
Figure 3: Marking of the 6 hole positions for the pop rivets

7. Drill dia. 4,1mm holes at the marked positions.
8. Flange the front edge of the baffle similar to the previous edge. Refer to Figure 4 for approximate flanging dimensions.
9. Cut out a baffle seal using the old one as a template.
10. Attach the baffle seal with the reinforcement strap to the front baffle using the DIN7337 – A – 4x8 pop rivets.
11. Reassemble all items in the reverse order.
