<b>XtremeAir GmbH, Harzstr.2, D-39444 Hecklingen</b> Tel: +49 39267 60999 0, Fax: +49 39267 60999 20 www.xtremeair.de info@xtremeair.de	Document No. <b>SB-2014-004</b>
		Issue: A.01
DOA-Nr.: EASA.21J.360	<b>Service Bulletin SB-2014-004</b>	Date: 21.07.2014

Subject: Wing tank fuel vent

Aircraft type affected: XA41-XA42

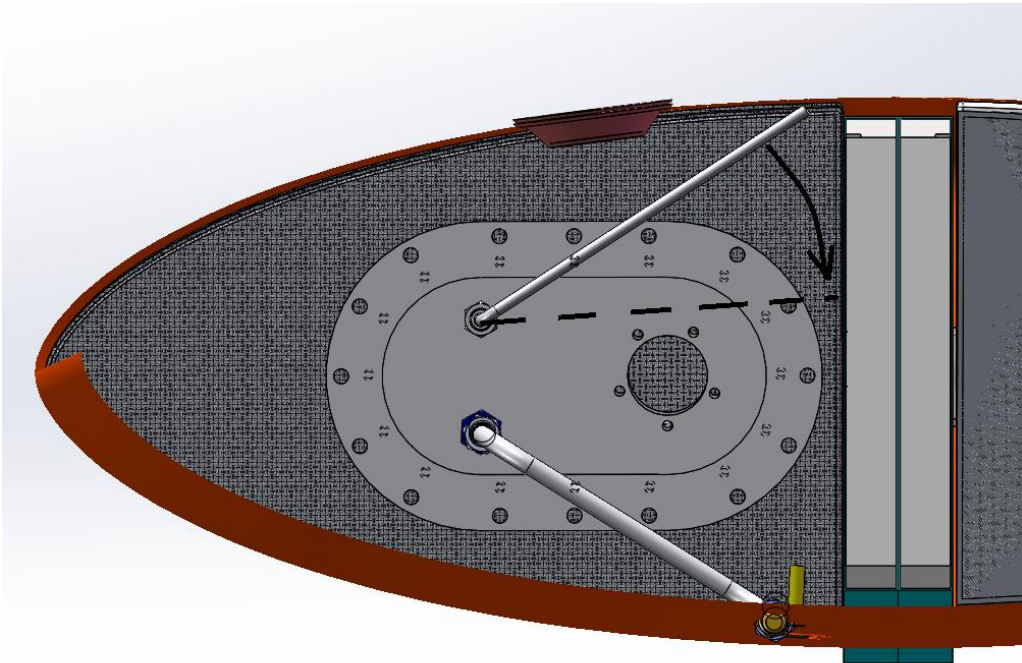
Background: The wing tank vent lines have a possibility of being obstructed against the wing spar due to production tolerances. This can be a problem during long cross-country flights where the fuel selector is not operated according to the AFM chapter 4.8 (switched between the LH and the RH wing tank each 30 minutes). The reliability of the fuel vent line system is improved by performing this service bulletin.

1. Empty the wing tank.
2. Remove the wing tank filler cap and identify through the opening the fuel vent tube on the tank plate.
3. Check the vertical movement of the vent tube. Check if it is possible for the tube to move to a nearly horizontal position

against the wing spar by which the fuel vent could get obstructed. (See Figure 1).

Figure 1: Vent line possible vertical movement to near horizontal position against the wing spar. (View on the inside of LH wing tank).

4. In case it could be obstructed, continue performing this service bulletin.
