<b>XtremeAir GmbH, Harzstr.2, D-39444 Hecklingen</b> Tel: +49 39267 60999 0, Fax: +49 39267 60999 20 www.xtremeair.de info@xtremeair.de	Document No. <b>SB-2014-003</b>
		Issue: A.02
DOA-Nr.: EASA.21J.360	<b>Service Bulletin SB-2014-003</b>	Date: 01.09.2014

**Subject:** Right hand Exhaust brace

**Aircraft type affected:** XA41-XA42

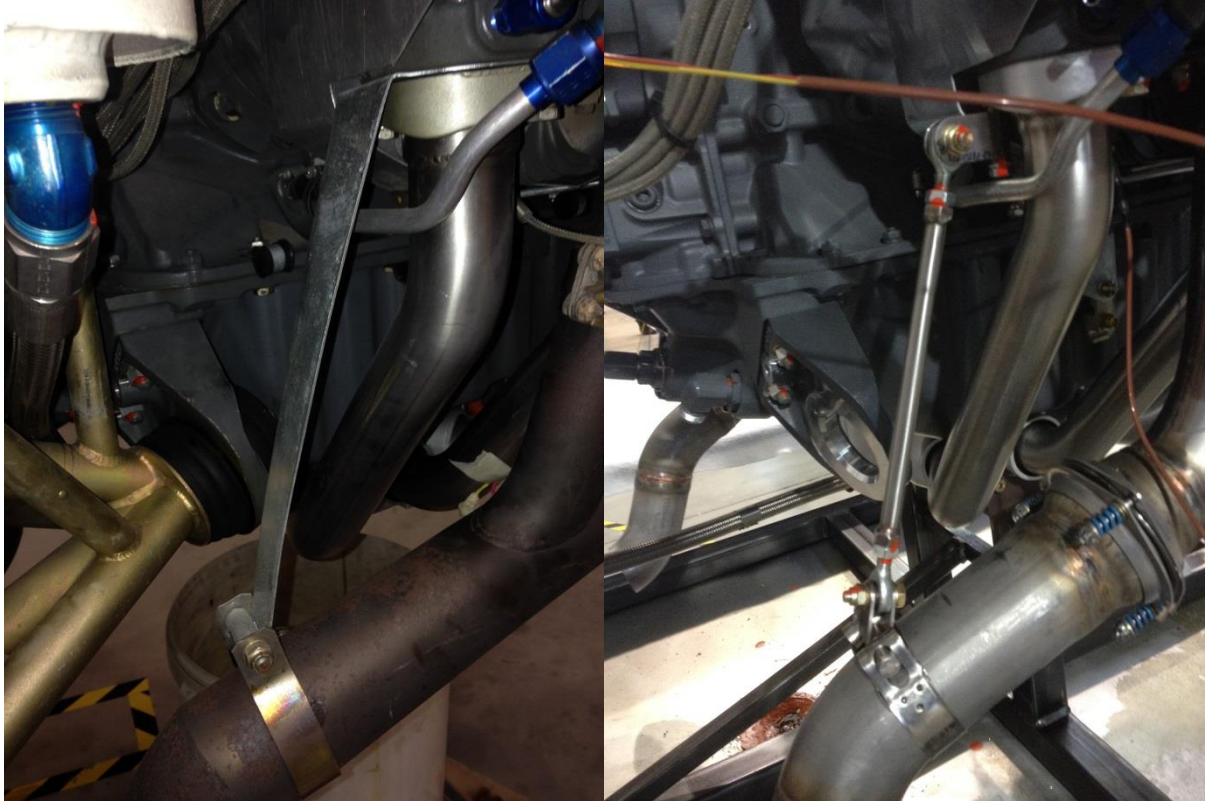
**Background:** On some aircraft the exhaust brace (XA42-7810-214) showed cracks. The new brace (XA42-7810-101) has a better resistance against cracks and is adjustable in length.

Figure 1: Old exhaust brace (XA42-7810-214) (Left); new exhaust brace (XA42-7810-101) (Right)

1. Remove the cowling in accordance with chapter 71-10-00 from the aircraft maintenance manual.
2. Remove the old right hand exhaust brace (XA42-7810-214) (see Figure 1, left).

3. Install the new exhaust brace (XA42-7810-101) between the RH exhaust clamp and the no.5 cylinder as seen in Figure 1 right and in Figure 2.
4. Reinstall the cowling in reverse order.

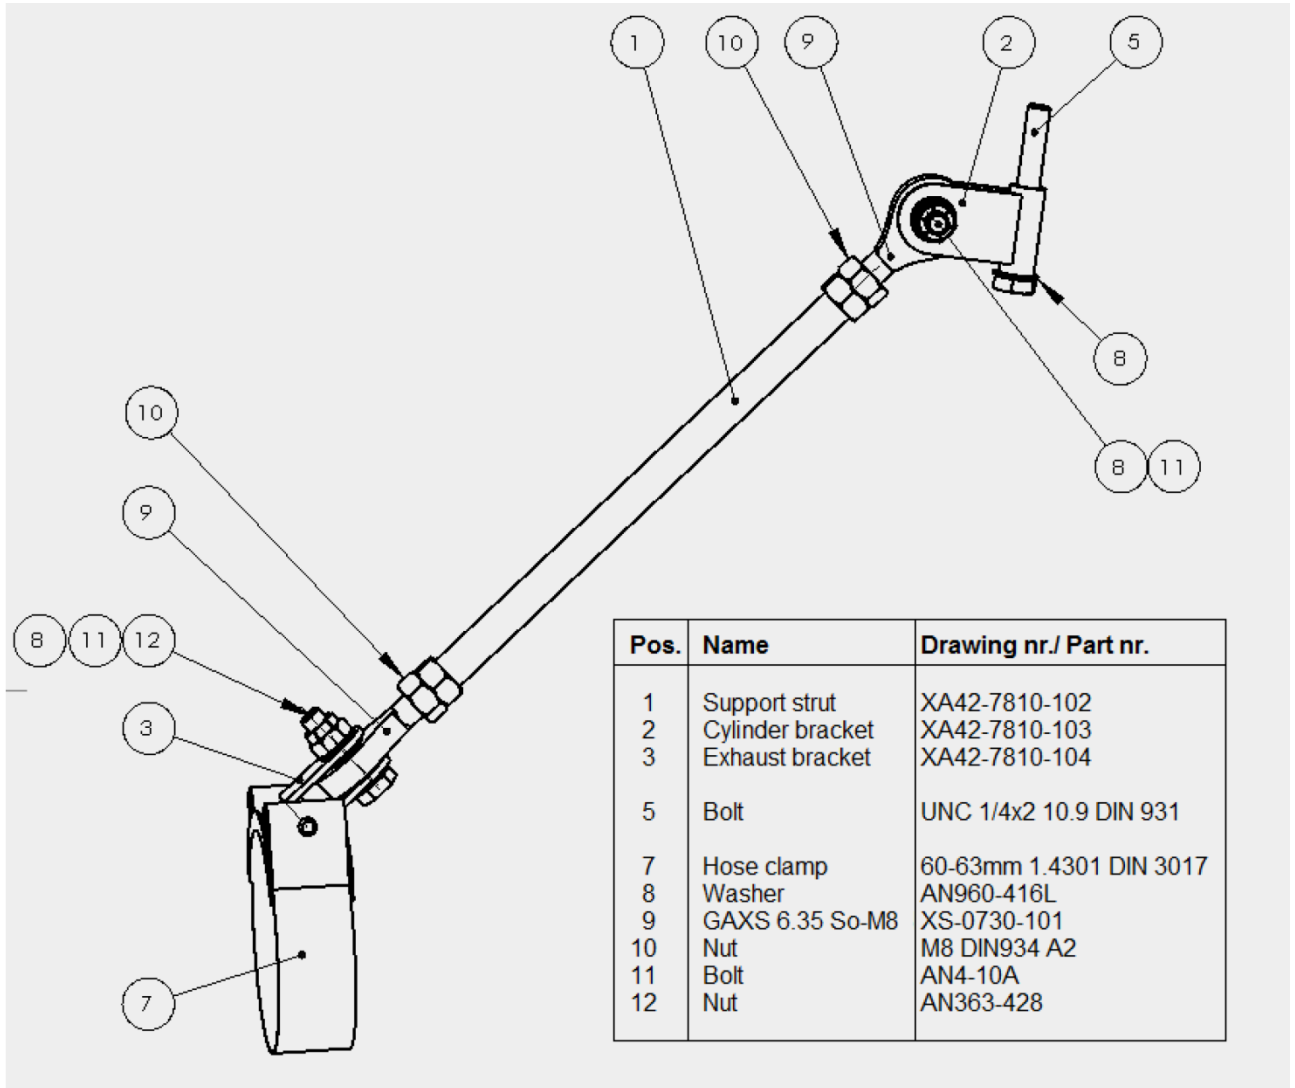
Figure 2: Assembly exhaust brace XA42-7810-101
