<b>XtremeAir GmbH, Harzstr.2, D-39444 Hecklingen</b> Tel: +49 39267 60999 0, Fax: +49 39267 60999 20 www.xtremeair.de info@xtremeair.de	Document No. <b>SB-2015-001</b>
		Issue: A.00
DOA-Nr.: EASA.21J.360	<b>Service Bulletin</b>	Date: 15.01.2015

Subject: Wing main spar bolts markings

Aircraft type affected: XA41-XA42

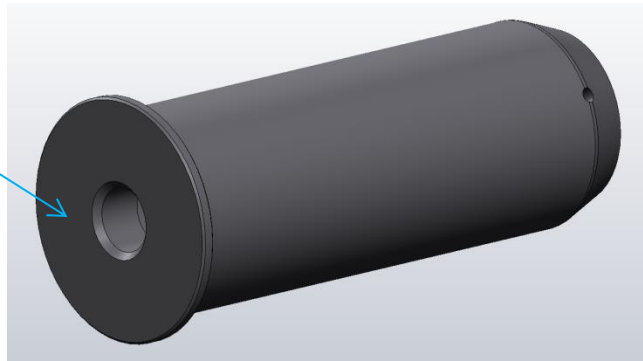
Figure 1: Main bolt marking location and content

Background: It was noticed that some wing main spar bolts are missing part number and serial number markings.

XtremeAir  
XA42-5320-250 A.01  
(Bolt s/n from Table 1)

1. Remove the foot covers inside the cockpit, in front of the wing spar.
2. Access the front of the main spar bolts and check for markings.
3. If markings are missing, mark the bolt head with the permanent marker with the information in Figure 1.
  - a. The serial number for each bolt is given in Table 1 according to the serial number of the aircraft.
4. Reinstall the foot covers.
