XtremeAir GmbH, Harzstr.2, D-39444 Hecklingen Tel: +49 39267 60999 0, Fax: +49 39267 60999 20 www.xtremeair.de info@xtremeair.de	Document No. SB-2015-002
		Issue: A.00
DOA-Nr.: EASA.21J.360	Service Bulletin SB-2015-002	Date: 13.04.2015

Subject:	Fuel pick-up
Aircraft type affected:	XA41 & XA42
Serial numbers affected:	MSN 101 – 135, 01 – 07
Compliance:	Optional
Time of Compliance:	At operator's discretion
Purpose:	To notify the owners of an improvement to the fuel pick-up.
Background:	More intake holes can be added to the fuel pick-up weight on the header tank.
Manpower:	It is estimated approximately two (2) man hours will be required to accomplish this bulletin.
Materials:	The following consumables are needed: "Epple 33"
Accomplishment Instructions:	<p>Read all the instructions and make sure the complete procedure is understood before starting the assembly work on the aircraft. In case of doubt, contact the manufacturer.</p> <ol style="list-style-type: none"> 1. Remove the flop tube assembly (XA42-2810-160) from the header tank iaw chapter 28-10-02 from the Aircraft Maintenance Manual. Note: It might be necessary to move the engine mount forward to have enough clearance to remove

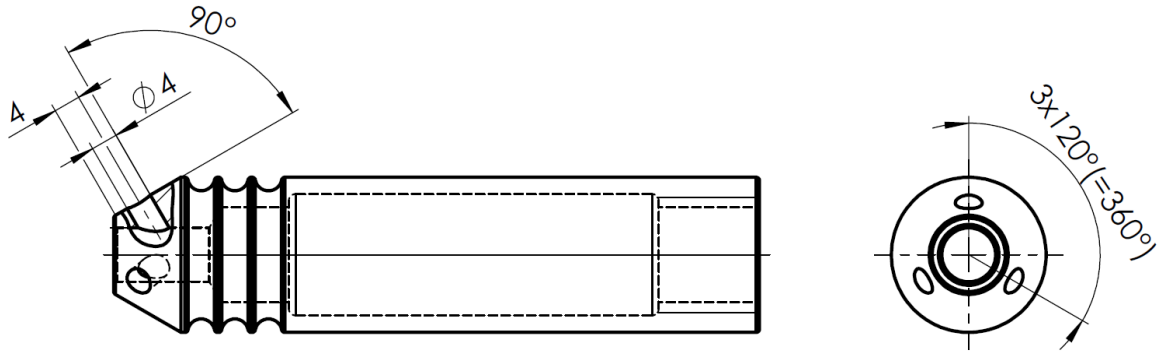
Figure 1: Fuel pick-up modification.
