XtremeAir GmbH, Harzstr.2, D-39444 Hecklingen Tel: +49 39267 60999 0, Fax: +49 39267 60999 20 www.xtremeair.de info@xtremeair.de	Document No. SB-2016-013
		Issue: A.02
DOA-Nr.: EASA.21J.360	Service Bulletin	Date: 24.10.2018

Subject: Installation of a single seat canopy

Aircraft type affected: XA42

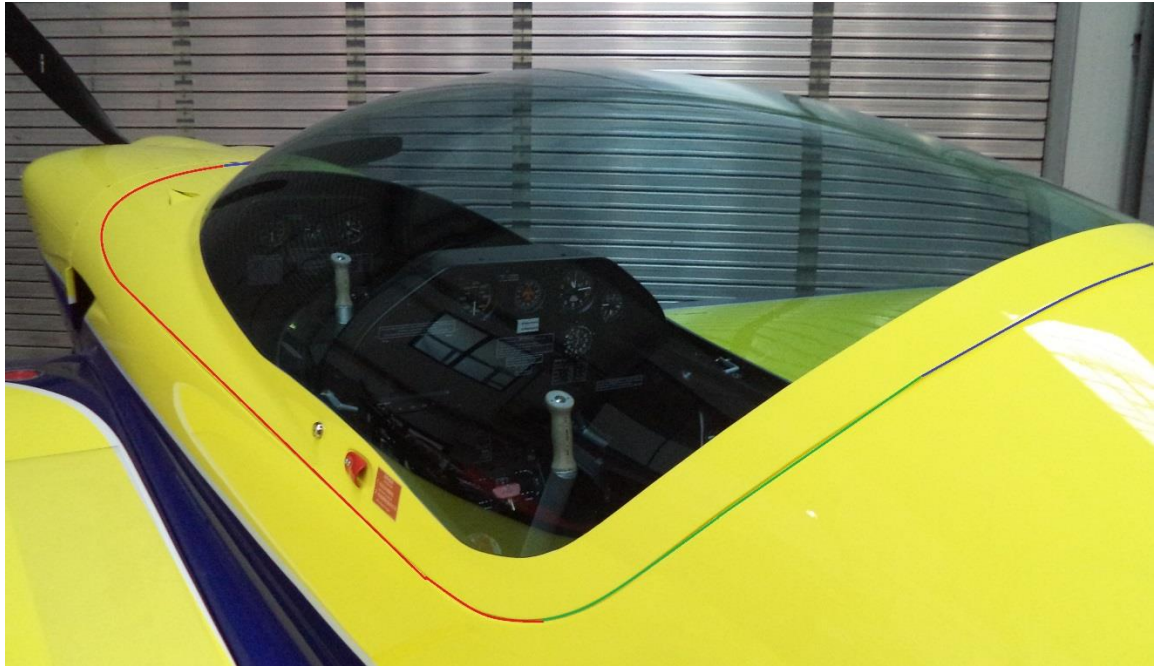
Figure 1: Circumferential clearance, red = 3mm, blue = 5mm, green = transition zone

1. Remove the standard double seat canopy in accordance with chapter 52-00-00 from Aircraft Maintenance Manual (AMM).
2. Install the delivered single seat canopy in accordance with chapter 52-00-00 from AMM.
3. Check if there is enough clearance between the canopy and fuselage at every opening position of the canopy.
4. If necessary, trim the edge of the canopy to get a circumferential clearance of approx. 3 mm (5 mm at the rear). Refer to figure 1. Paint the laid open edges in accordance with chapter 51-70-15 AMM.
