XtremeAir GmbH, Harzstr.2, D-39444 Hecklingen Tel: +49 39267 60999 0, Fax: +49 39267 60999 20 www.xtremeair.de info@xtremeair.de	Document No. SB-XA42-2018-006
		Issue: A.00
DOA-Nr.: EASA.21J.360	Service Bulletin	Date: 2 MAR 2018

Subject:	Engine Mount Inspection
Aircraft models affected:	XA42 & XA41
Applicability:	Manufacturers serial numbers (MSN) 01 to 07 and 101 to 149 equipped with engine mount P/N XA42-7120-151
Compliance:	Mandatory
Time of Compliance:	1.) Initial visual inspection within the first 50 hours of operation of the engine mount or before the next flight 2.) Repetitive visual inspections after each 10 aerobatic flights*
Purpose:	To detect a potentially unsafe condition.
Background:	A crack was detected on an engine mount frame diagonal strut during a scheduled maintenance inspection. If not detected, the crack could grow and subsequent partial or complete failure of the structural joint possibly result in in-flight detachment of the engine and consequent loss of control of the aeroplane.
Manpower:	Approximately ten (10) minutes are required to perform each inspection
Materials:	An inspection mirror and a flashlight are required to perform the inspection without remo

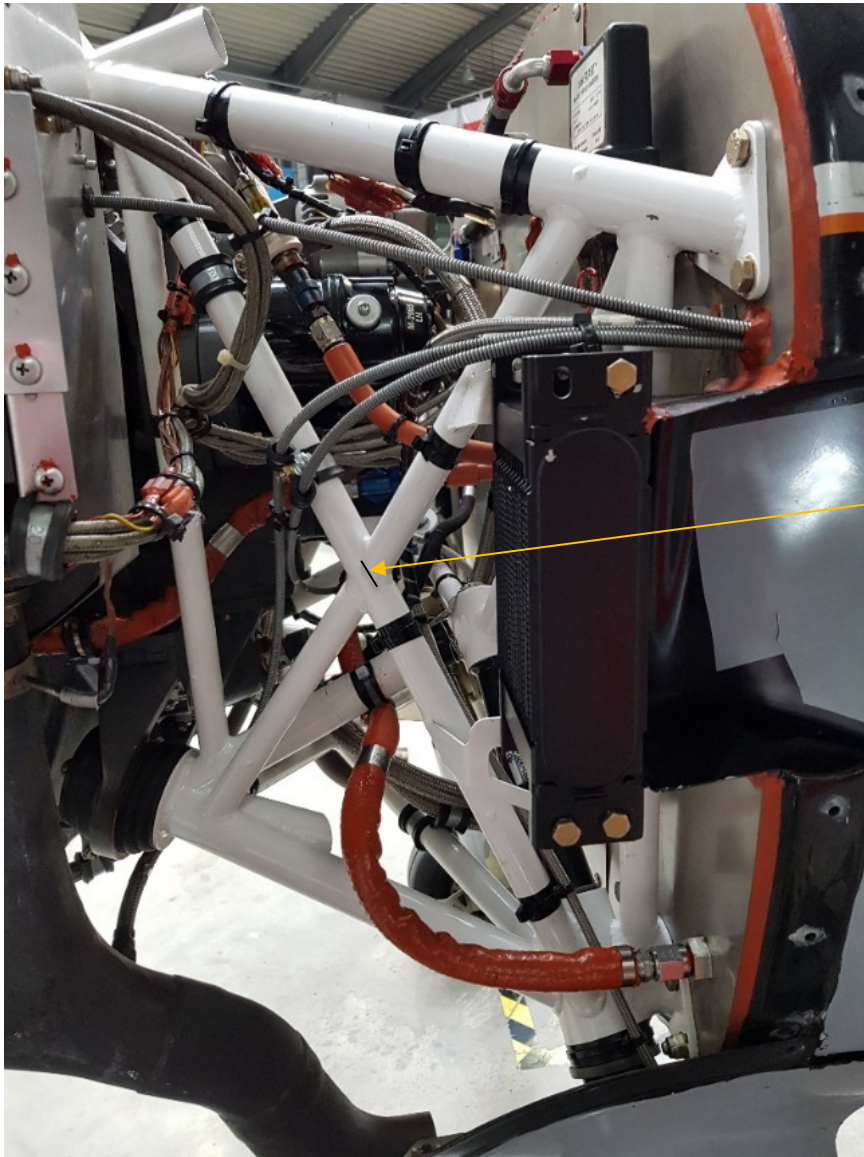
Accomplishment Instructions:	Prior to the next flight and after each ten (10) aerobatic flights* thereafter, visually inspect the area of the junction of the L/H diagonal struts of the engine mount, forward of the oil cooler, for cracks. * each flight during which a load factor of 6 g is exceeded

LOOK FOR
CRACK HERE

If a crack exists, remove and replace the engine mount.
