XtremeAir GmbH, Harzstr.2, D-39444 Hecklingen Tel: +49 39267 60999 0, Fax: +49 39267 60999 20 www.xtremeair.de info@xtremeair.de	Document No. SB-XA42-2018-016
		Issue: A.00
DOA-Nr.: EASA.21J.360	Service Bulletin	Date: 20.06.2018

Subject:	Pilot's seat replacement
Aircraft type affected:	XA42
Serial numbers affected:	MSN 101 – 151
Compliance:	As user discretion
Time of Compliance:	During the next scheduled maintenance
Purpose:	To notify the owner of the subject aircraft of an optional replacement of the rear seat.
Background:	Contact between the shoulder harness and the rear seat can lead to cracks around the shoulder harness openings on the rear seat.
Manpower:	It is estimated that one (1) man-hours is necessary to apply this service bulletin.
Materials:	<p>The following materials are necessary and can be ordered through spares@xtremeair.de</p> <p>(1) ea. XA42-2510-205 Rear seat or: (1) ea. XA42-2510-206 Rear seat sight carbon and: (1) ea. XA42-5370-238 Headset plug socket cover (2) ea. AN4-11A Hexagon head bolt (2) ea. MS21083-N4 Self-locking nut (6) ea. AN960-416L Flat washer</p> <p>Consumables:</p> <ul style="list-style-type: none"> - Alcohol – or equivalent solvent cleaner - Ad

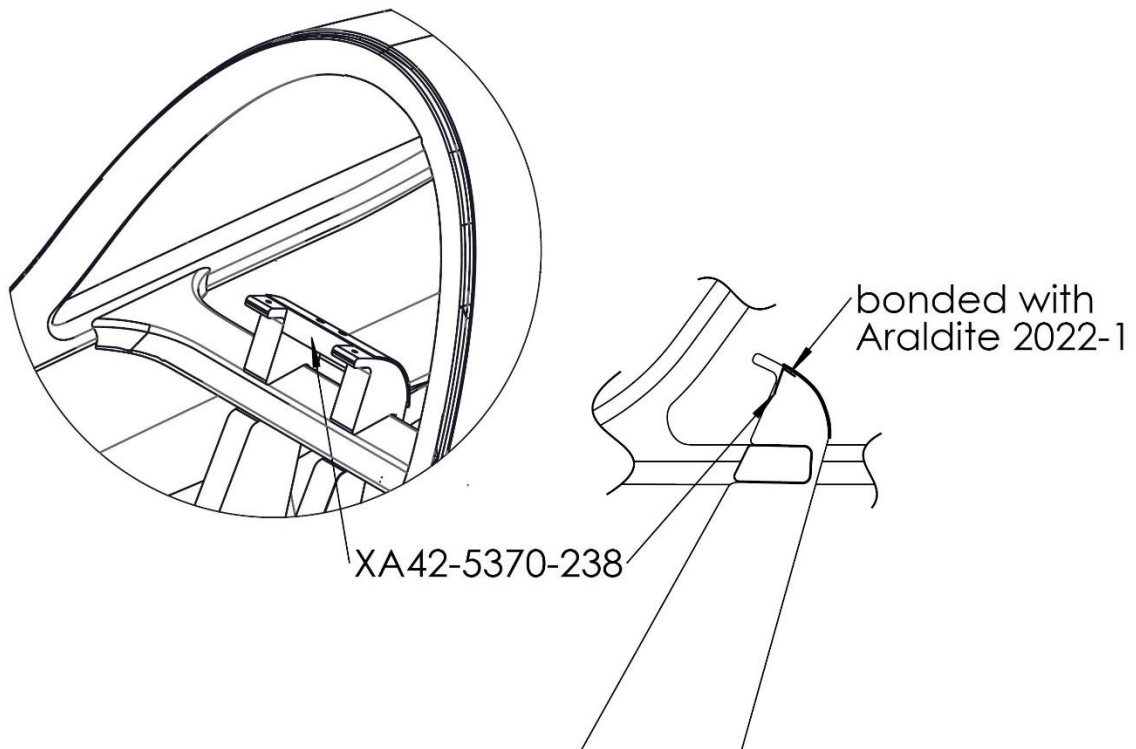
Figure 1: Position of the headset plug socket cover

2. Exchange the fasteners of the pilot's shoulder harness with the delivered ones. Refer to chapter 25-10-02 of the AMM.
3. Identify the area to be prepared for the bonding of the headset plug socket cover to the headset plug support. Refer to Figure 1.
4. Prepare the headset plug socket support for bonding from the inside using P120 grit sandpaper.
5. Clean the surface to be bonded (dust and grease free).
6. Bond the headset plug socket cover XA42-5370-238 in accordance with Figure 1. Refer to the manufacturer's instruction for further handling advices.
7. Leave cure for at least 1 hour at room temperature.
8. Install the delivered rear seat XA42-2510-205 in accordance with chapter 25-10-01 of the AMM.
