XtremeAir GmbH, Harzstr.2, D-39444 Hecklingen Tel: +49 39267 60999 0, Fax: +49 39267 60999 20 www.xtremeair.de info@xtremeair.de	Document No. SB-XA42-2019-008
		Issue: B.00
DOA-Nr.: EASA.21J.360	Service Bulletin	Date: 04 DEC 2019

MANDATORY

Subject:	Engine Mount Inspection
Aircraft models affected:	XA42 & XA41
Applicability:	Manufacturers serial numbers (MSN) 01 to 07 and 101 to 156 equipped with engine mount P/N XA42-7120-151
Compliance:	Mandatory, SB will be followed by an EASA AD
Time of Compliance:	1.) Initial visual inspection within the first 50 hours of operation of the engine mount or before the next flight 2.) Repetitive visual inspections after each 10 aerobatic flights*
Purpose:	To detect a potentially unsafe condition.
Background:	A crack was detected on an engine mount frame diagonal strut during a scheduled maintenance inspection. If not detected, the crack could grow and subsequent partial or complete failure of the structural joint possibly result in in-flight detachment of the engine and consequent loss of control of the aeroplane.
Manpower:	Approximately ten (10) minutes are required to perform each inspection
Materials:	An inspection mirror and a flashlight are

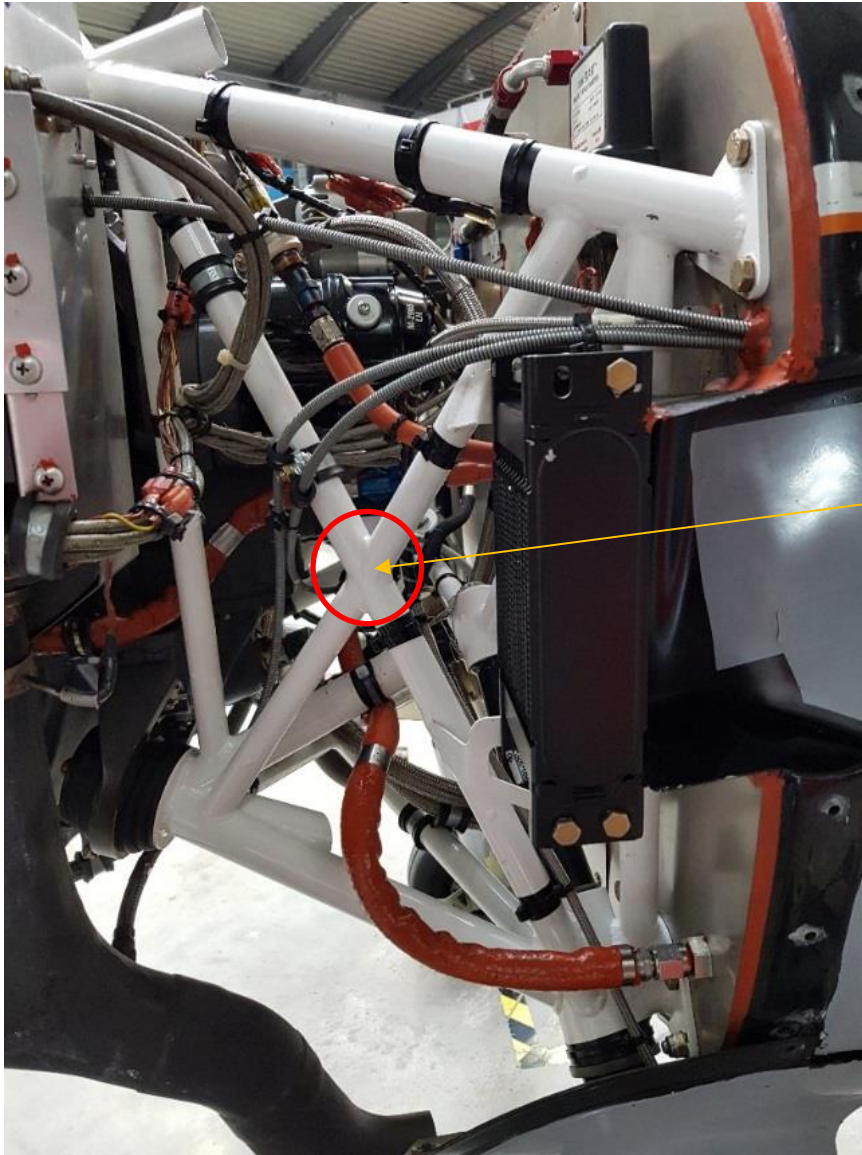
Accomplishment Instructions:	In addition to AFM chapter 4.3 section L, prior to the next flight and after each ten (10) aerobatic flights* thereafter, visually inspect the area of the junction of the L/H and R/H diagonal struts of the engine mount, forward of the oil cooler, for cracks. * each flight during which a load factor of 6 g is exceeded

LOOK FOR
CRACK HERE

If a crack exists, remove and replace the engine mount.
